Manhole Inspection Summary

Manhole # S41AA_012MH

Insp Date: **11/11/08 2:36 PM**

Location Address: **1500 e monument st**

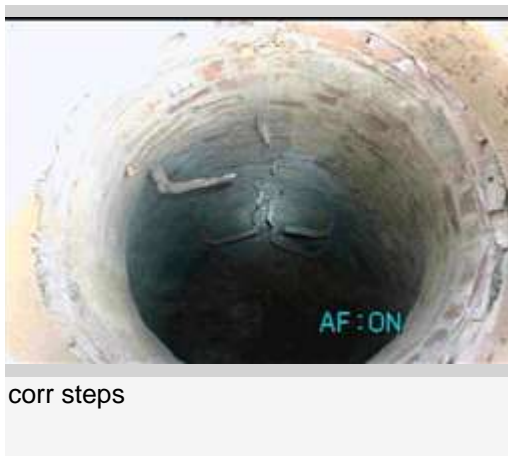
Defect 3

Count: **6** Missing: **4** ☒ **Corroded**

corr steps

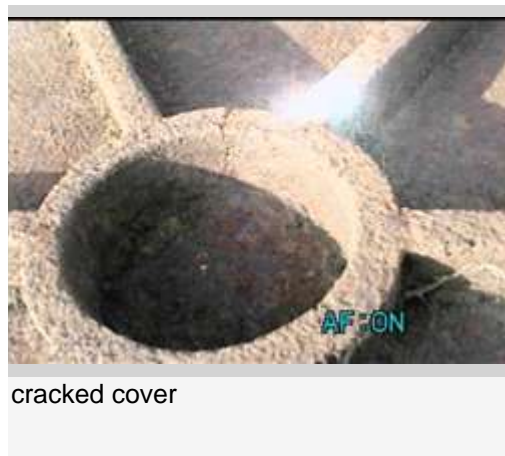
Defect 2

Condition: **Cracked**

cracked cover

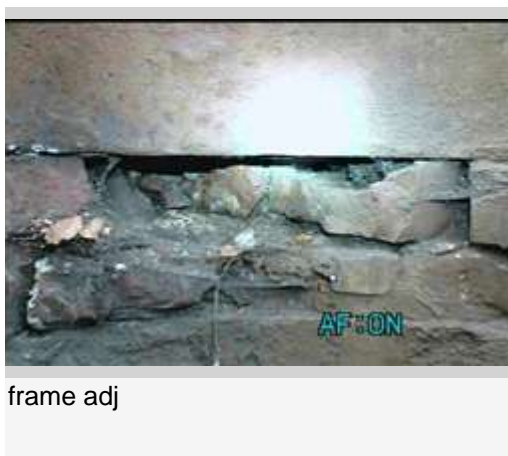
Defect 1

Condition: ☐ Sound ☒ **Cracked** ☐ Root Intrusion ☒ **Loose Brick** ☒ **Deteriorated**

frame adj
